NIST NCSTAR 1-5A

Federal Building and Fire Safety Investigation of the World Trade Center Disaster

Visual Evidence, Damage Estimates, And Timeline Analysis

(Chapter 9 - Appendix C)

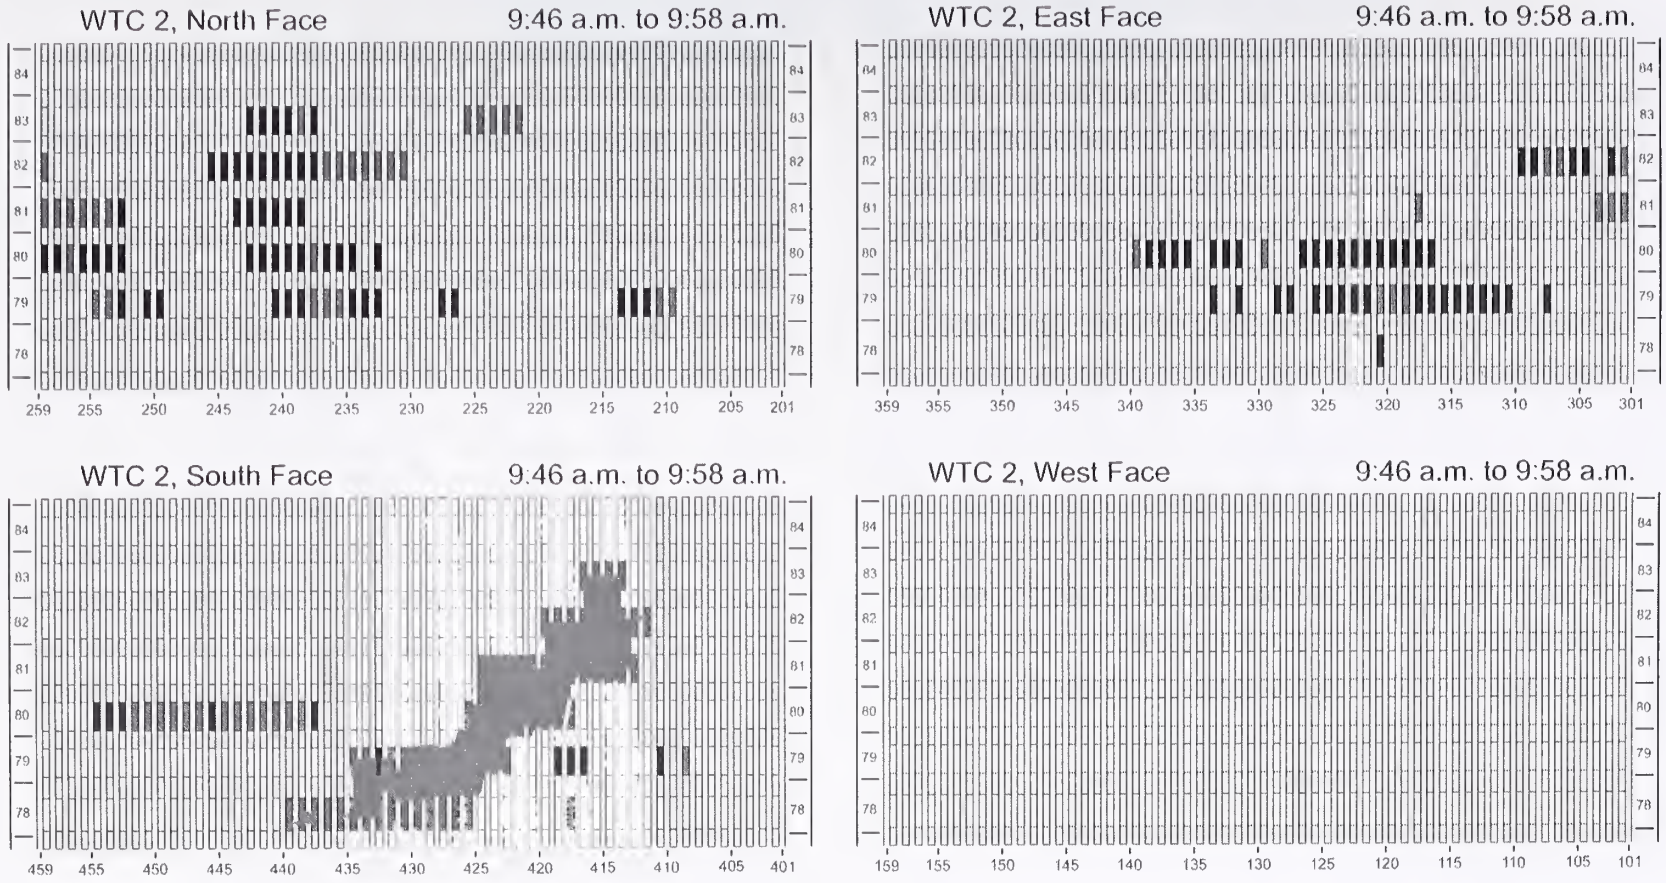
Façade maps of integrated fire intensities for the period from 9:45 a.m. to 9:59 a.m. are shown in Figure 9–88. Comparison with the corresponding maps for the 9:29 a.m. to 9:45 a.m. period shown in Figure 9–60 is helpful for tracking the changes in fire distributions during the current period.

Many of the fires observed during earlier periods were either no longer visible or were dying down during the final interval prior to the tower collapse. Fires dying down included those burning on debris piles located in the northeast corner of the tower and near the center of the north face on the 79th floor, a fire that had earlier burned from south to north across the 82nd floor on the east face, and numerous small fires ignited around the aircraft impact cavity on the south face.

At the same time, fires spread to areas of the faces that had not been involved earlier, including the north face toward the west on the 79th, 82nd, and 83rd floors. There was also an indication that fire may have spread upward on the north face from the 83rd to the 84th floor. The fire growth and local spread on the 79th floor of the north face appeared to be rapid and took place at a location that was apparently removed from earlier fires. This may be an indication that fire spread to this area on the faces occurred from interior locations within the tower that were not visible from outside. The new areas of fire which appeared on both the 79th and 83rd floors developed rapidly and remained localized at a few windows. These behaviors suggest that these fires had spread into rooms with walls that terminated at nearby façade columns and limited further fire spread. On the 79th floor, flames were seen in window 79-209 to window 79-212. A floor plan layout for the 79th floor is shown in Figure B-10 in Appendix B. It indicates that a room was not present behind these windows. A room is indicated in the northwest corner with walls at columns 79-208 and 79-154. The fire on the 83rd floor appeared in windows 83-221 to 83-225. Unfortunately, a floor plan layout for this floor is not available for comparison. The visual evidence indicates that none of the spreading fires on the north face reached as far as the west face prior to the tower collapse.

Figure 9-88. Maps of integrated fire observations between 9:45 a.m. and 9:59 a.m. are shown for the four faces of WTC 2. Colors represent the highest intensity fire observed in a window using the color scale defined in Figure 5-1.

Between 9:45 a.m. and 9:59 a.m. there were at least four periods during which intense smoke flows and some flames appeared suddenly from windows near the centers of the 79th and 80th floors of the east face, only to subside roughly a minute later. Similar, but more intense, behaviors had been observed between 9:29 a.m. and 9:45 a.m. and were tentatively attributed to burning of pools of aviation fuel located somewhere within the interior of the tower. During the period, sustained fires, with behaviors more typical of building fires, were also observed on the 79th and 80th floors. On the 79th floor these flames extended from roughly windows 79-310 to 79-320 and on the 80th floor from windows 80-315 to 80-326. At the start of the period, the flames on the 79th floor were heavier and generated smoke that partially obscured the 80th floor. By the end of the period, these flames had died down and had receded into the building, and little smoke was coming from the nearby windows. The fire on the 80th floor did not appear to generate external flames, and little smoke was visible coming from nearby windows. A fire that had been burning on a pile of debris in the northeast corner of the 81st floor since the aircraft impact was still present.

On the south face, several relatively small fires that had developed earlier around the aircraft impact cavity continued to die down or disappeared from view. More substantial fires that had been present at the eastern edges of the face on the 81st and 82nd had also died down. By around 9:50 a.m. very little fire was visible on the façade. Between 9:52 a.m. and 9:54 a.m. a fire became visible and rapidly spread along the west side of the face on the 80th floor. The only earlier indication of fire development at this location was a short flame flare up observed from window 80-439 at 9:47:50 a.m. and a small flame at this location. Just prior to 9:57 a.m. the fire grew rapidly, and large flames were observed coming from windows in the area. At the time of the tower collapse, this fire extended from roughly window 80-437 to 80-454.

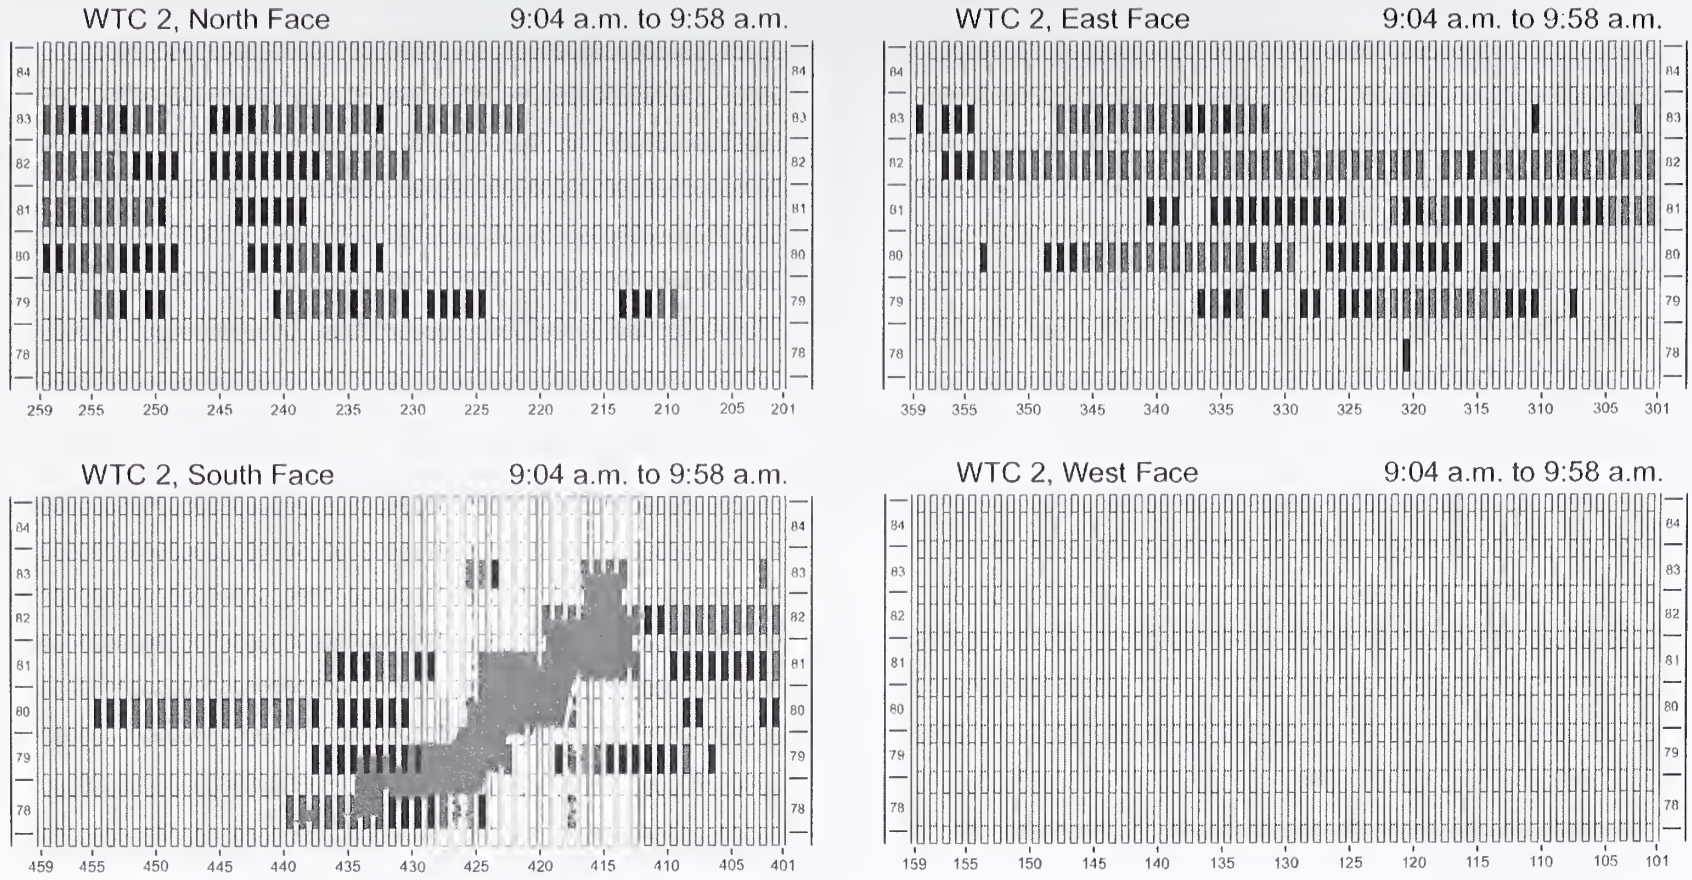
Compared to WTC 1, the amount of fire spread in WTC 2 was less extensive during the 56 min between the impact of United Airlines Flight 175 and the collapse of the tower. One approach for characterizing the fire spread in WTC 2 is to compare integrated façade maps for the entire period from 9:03 a.m. to 9:59 a.m. with the initial fire distributions shortly after the aircraft impact. Figure 9–89 shows fire maps for the four faces obtained by integrating the fire datasheets over the entire period. These maps are compared with the corresponding fire distributions around 9:04 a.m. in Figure 9–90.

Figure 9-89. Maps of integrated fire observations between 9:03 a.m. and 9:59 a.m. are shown for the four faces of WTC 2. Colors represent the highest intensity fire observed in a window using the color scale defined in Figure 5-1.

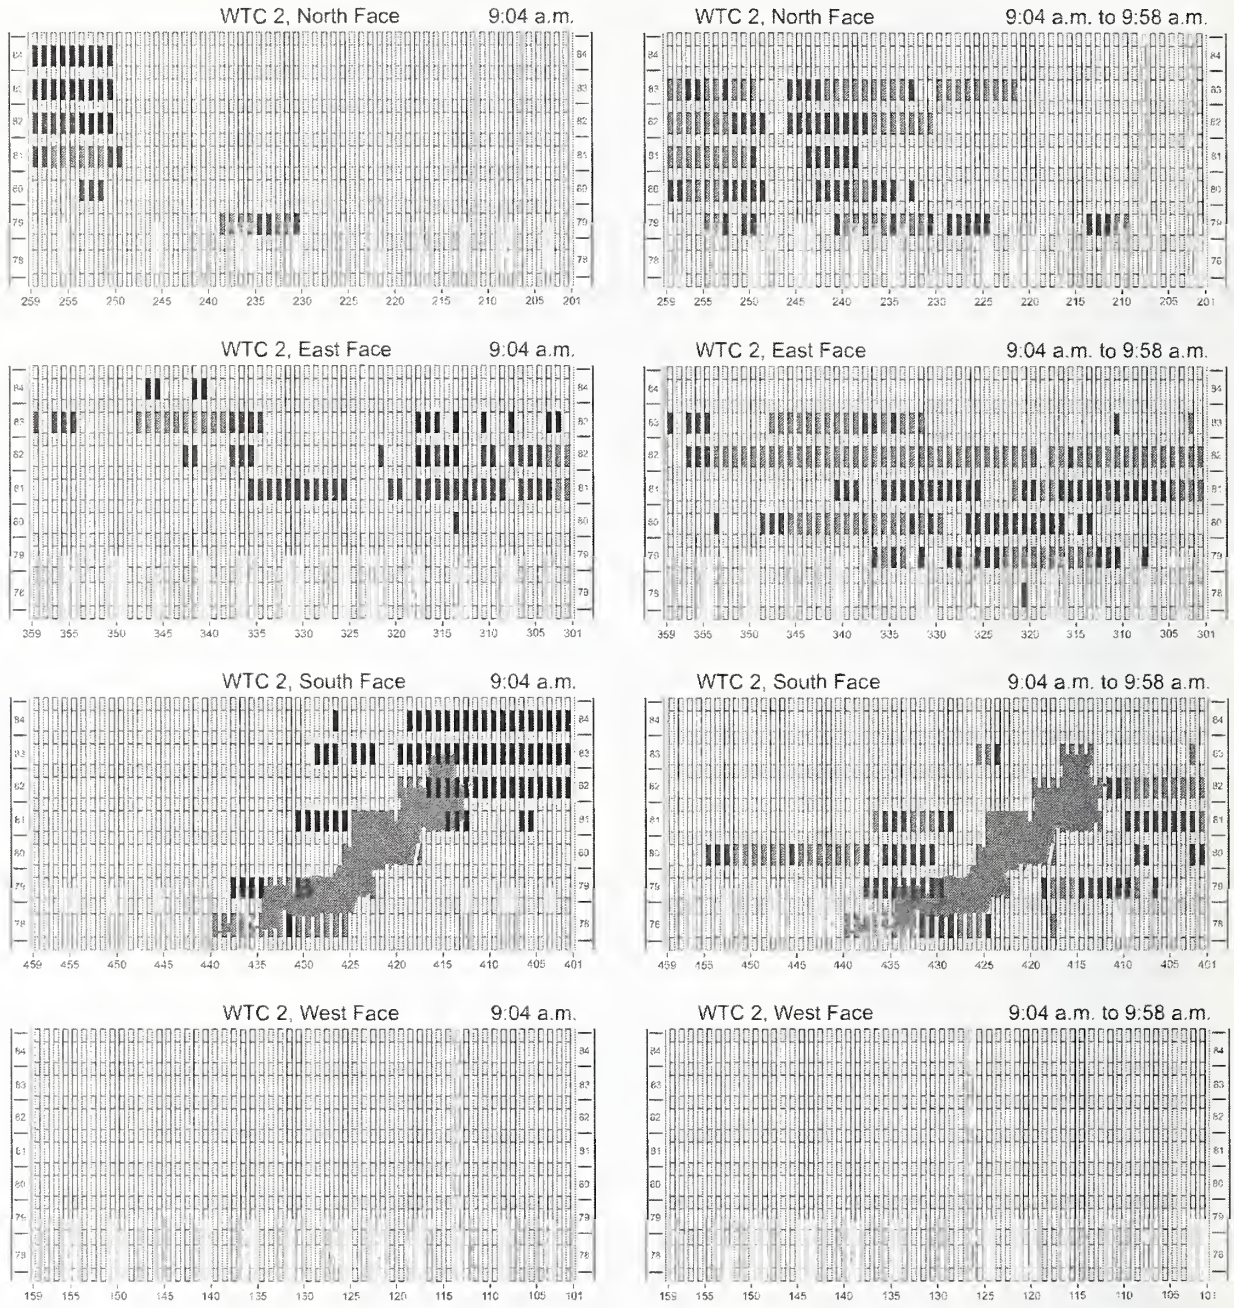
Figure 9-90. Maps of observed fire distributions on the four faces of WTC 2 shortly after the aircraft impact (near 9:04 a.m.) are compared with the corresponding integrated fire observations for the entire period between 9:03 a.m. and 9:59 a.m. The data for 9:04 a.m. are represented using the color scale in Figure 5-1. For the integrated results, the same color scale is used to represent the highest intensity fire observed in a given window during the period.

On the north face significant fire spread took place on the 79th, 82nd, and 83rd floors. The effects of this fire spread are revealed by areas of fire (Figure 9–90) and opened windows (Figure 9–91) on the west sides of the areas of fire and open windows that were present shortly following the aircraft impact and fireballs. On the 79th floor this fire growth took place from the large fire burning on a pile of debris just to the east of the center of the face. Despite the presence of this sustained fire, westward fire spread on this floor was relatively slow and sporadic. The fire spread on the 82nd floor occurred just to the west of the cold spot (an area on the 80th, 81st, and 82nd floors between columns 238 and 250). Fire spread into this area was not observed until around 9:54 a.m. On the 83rd floor fire spread occurred in discrete segments that suggested fire was spreading across a series of rooms. The first large fire appeared just above the cold spot around 9:29 a.m. None of the fires that spread to the west on the north face appeared to reach the western edge of the tower by the time of collapse.

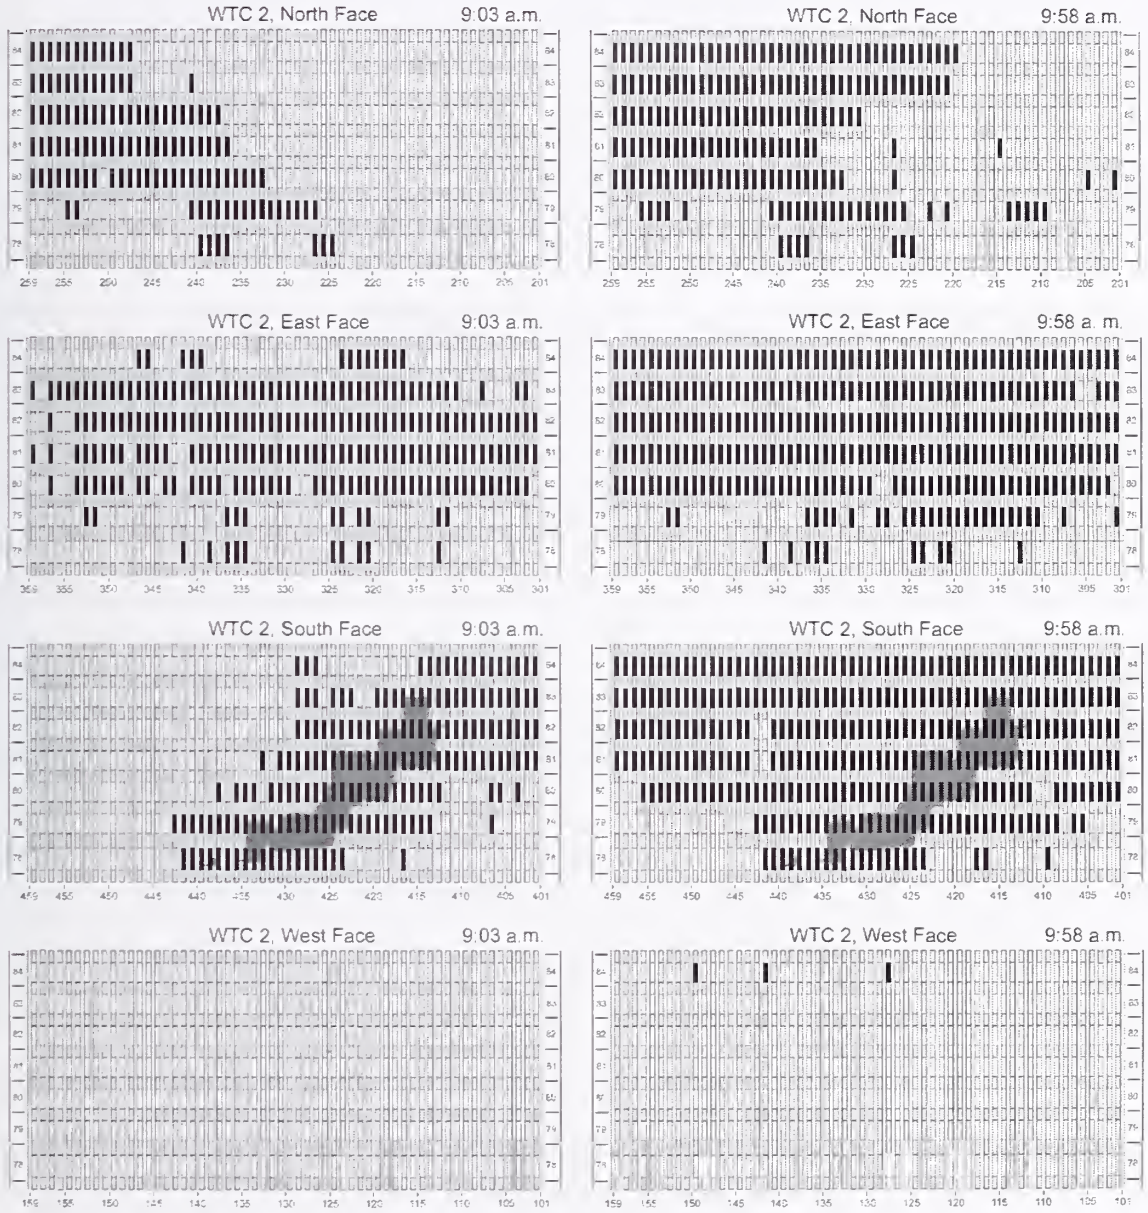
Similar to the analyses included in Chapter 8, changes in window condition can also be used as a rough indicator of fire spread. This analysis method has been used to the complement the integrated fire data. The results are shown in Figure 9–91. It should be kept in mind that this approach only reveals fire spread that occurs to locations where windows were originally unopened. This is particularly important for WTC 2 because the number of windows opened by the aircraft impact and subsequent fireballs was much larger than for WTC 1. Even so, the analysis does provide a good estimate for fire spread into areas where window glass was still in place immediately following the aircraft impact.

Figure 9-91. Maps for the 78th through the 84th floors compare missing window glass for the four faces of WTC 2 at two times, immediately following the aircraft impact at 9:02:59 a.m. and just prior to the collapse of WTC 1 at 9:58:59 a.m.

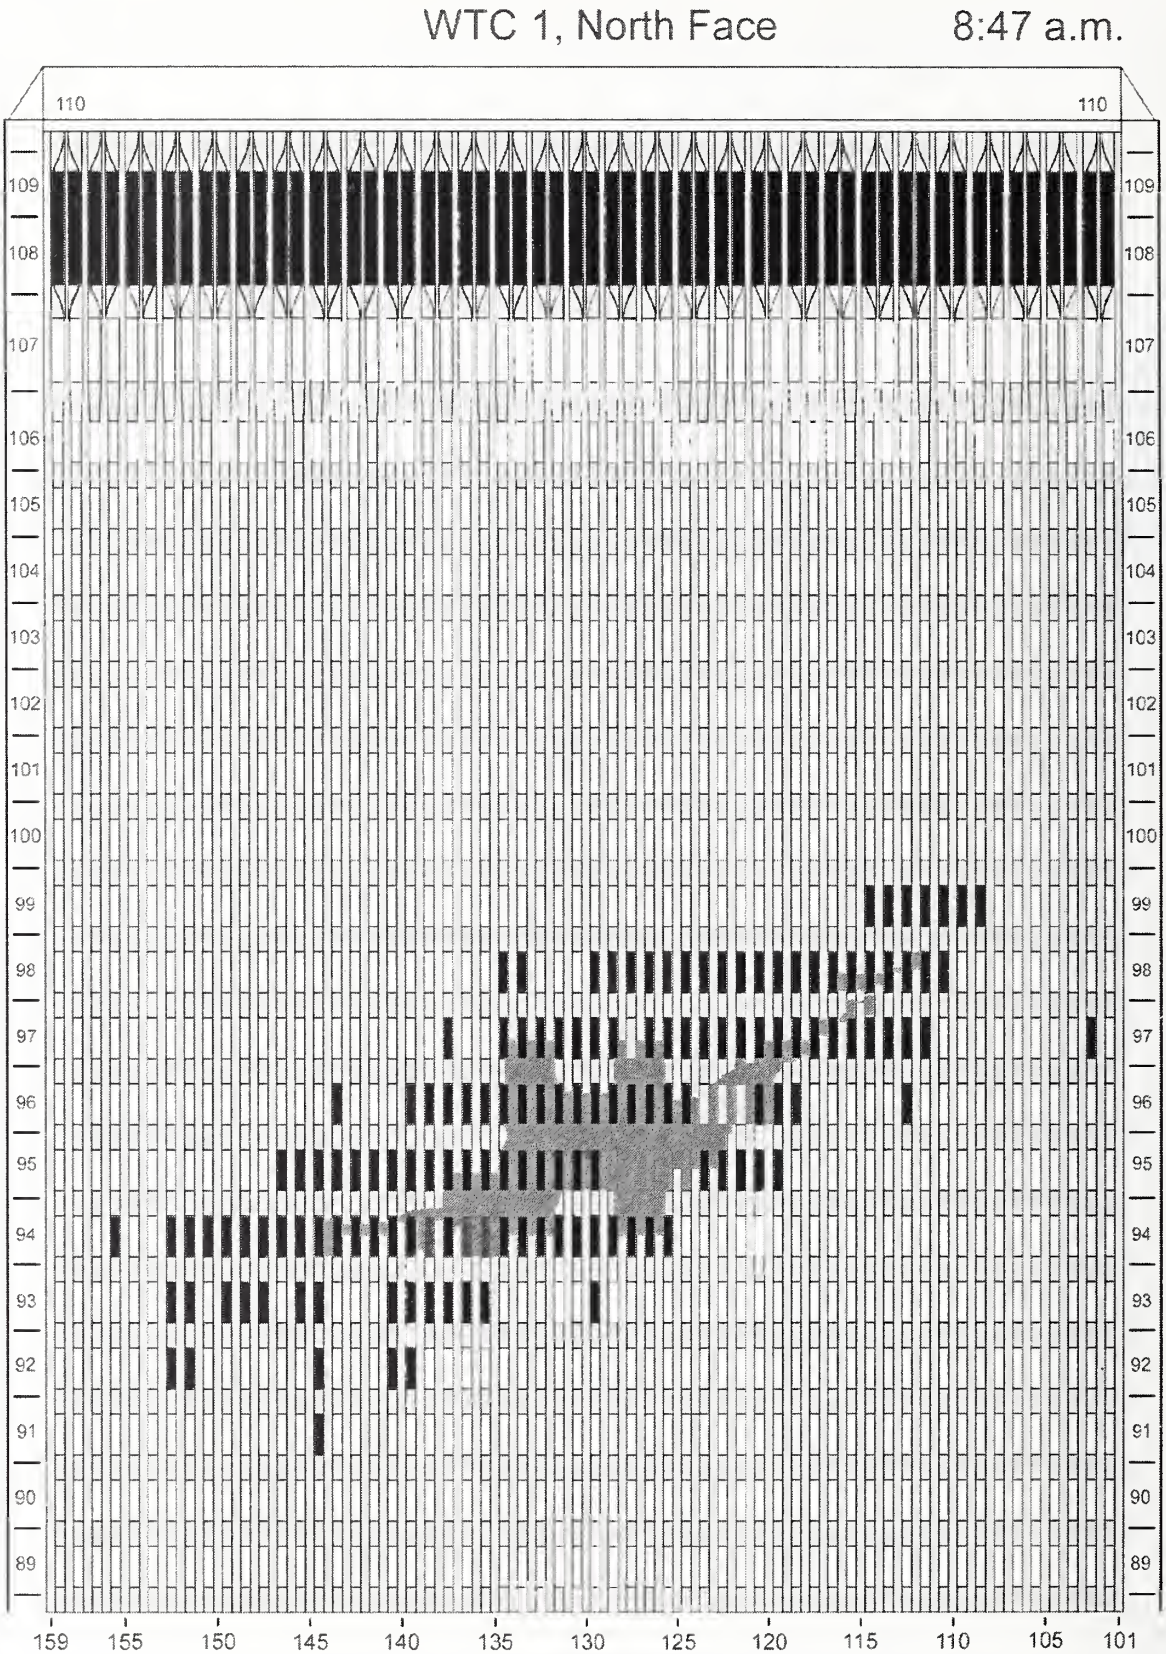
Figure C-1. Diagram of the north face of WTC 1 for floors 89 to 110 at 8:47 a.m. showing the condition of windows and locations of fires.

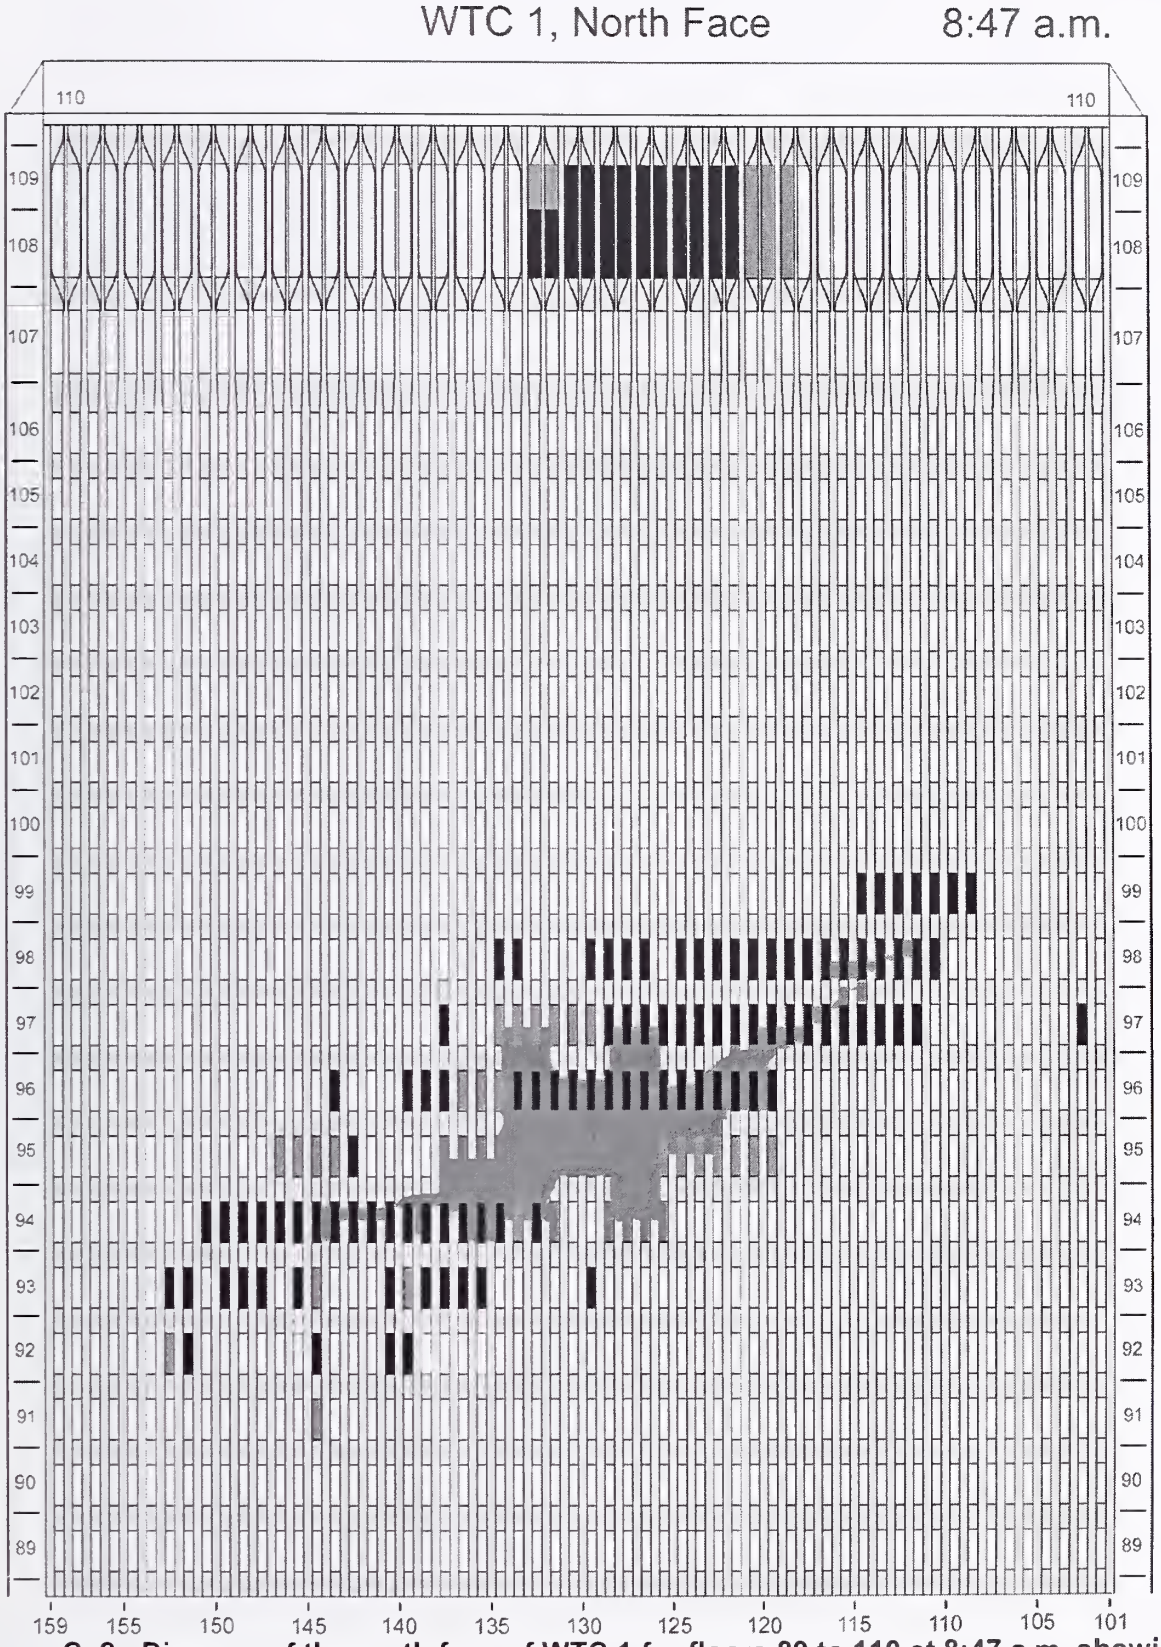
Figure C–2. Diagram of the north face of WTC 1 for floors 89 to 110 at 8:47 a.m. showing windows where smoke was observed and those that were hidden from view.

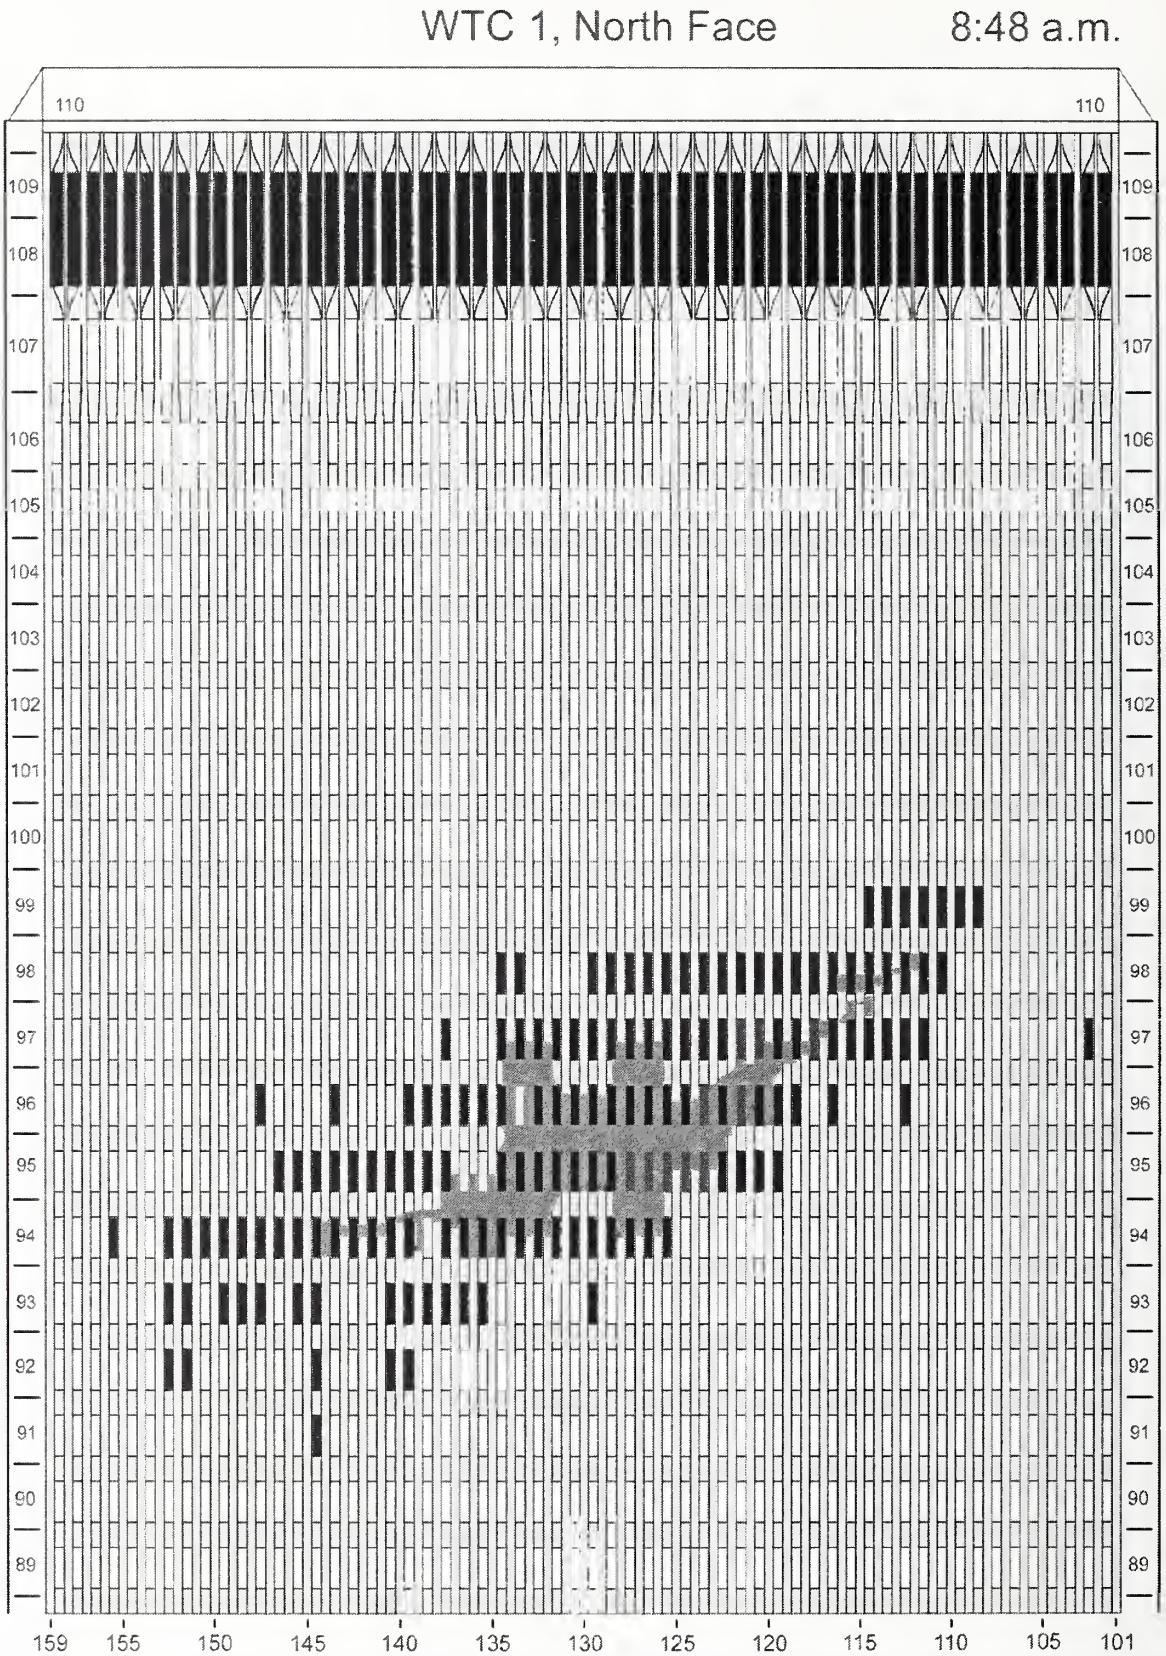
Figure C–3. Diagram of the north face of WTC 1 for floors 89 to 110 at 8:48 a.m. showing the condition of windows and locations of fires.

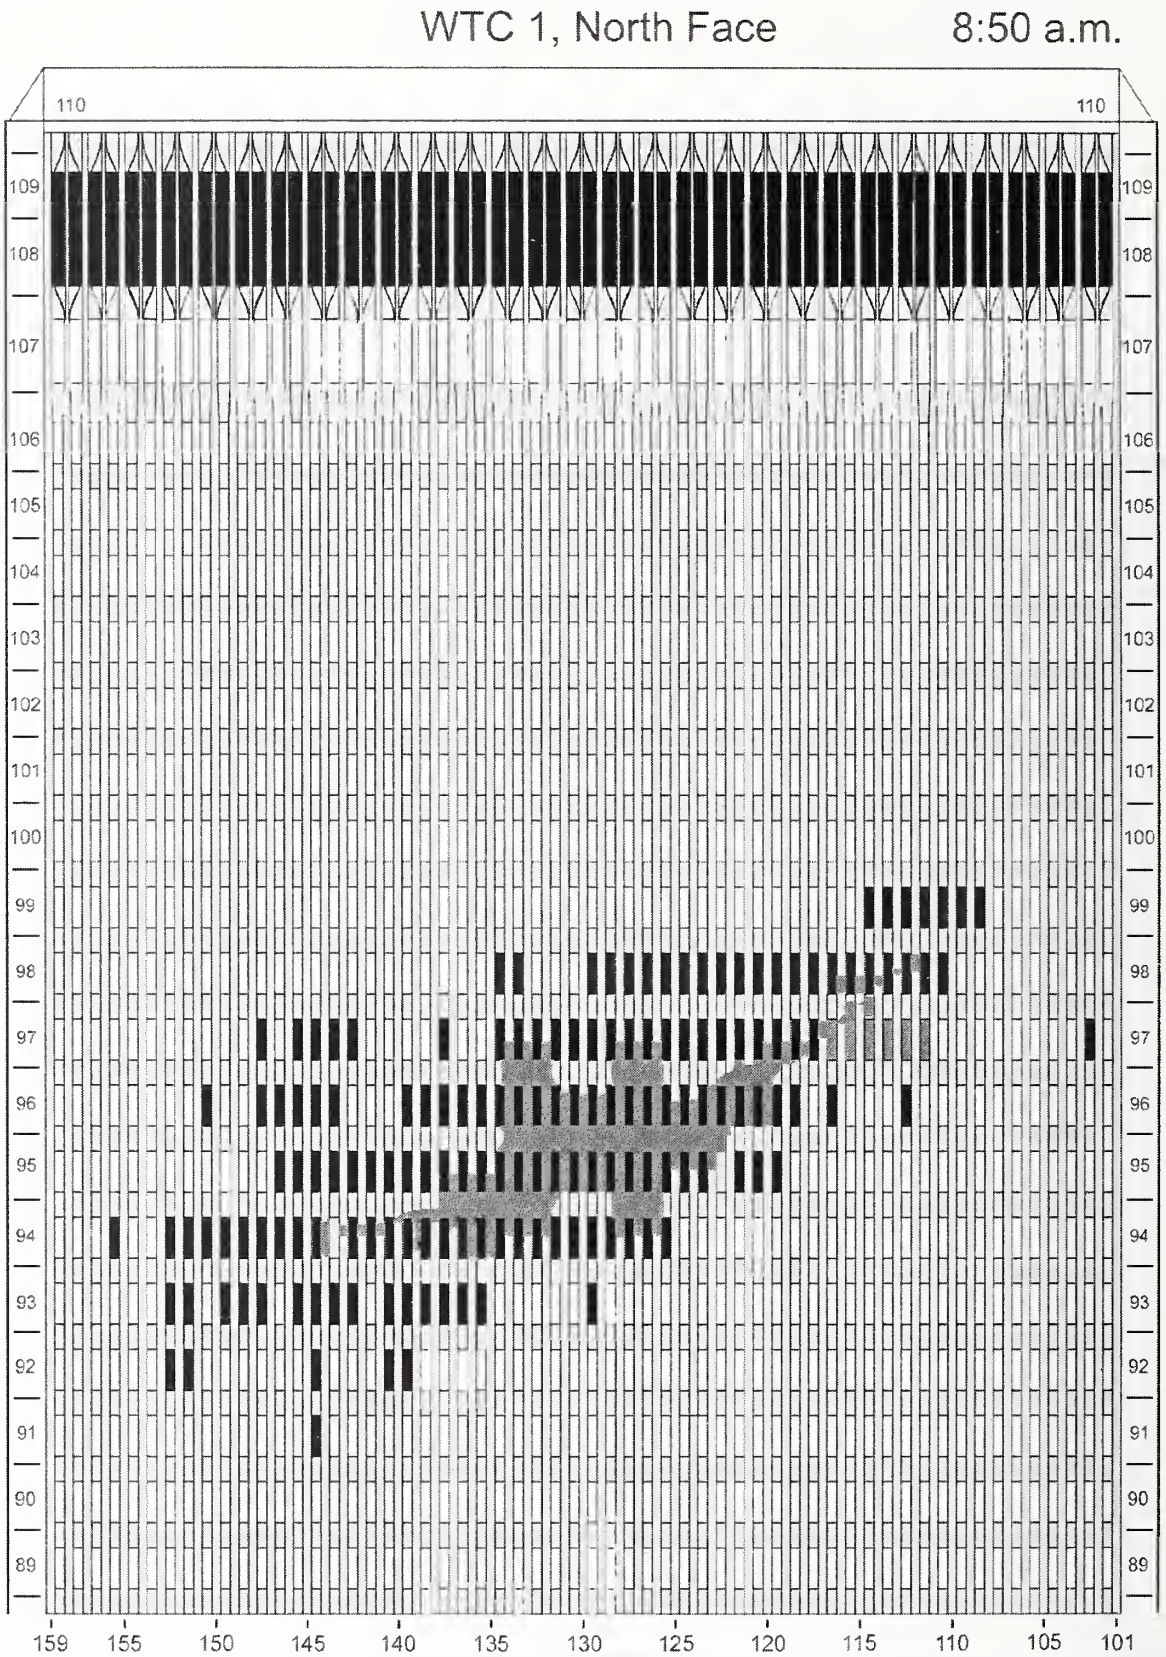
Figure C-5. Diagram of the north face of WTC 1 for floors 89 to 110 at 8:50 a.m. showing the condition of windows and locations of fires.

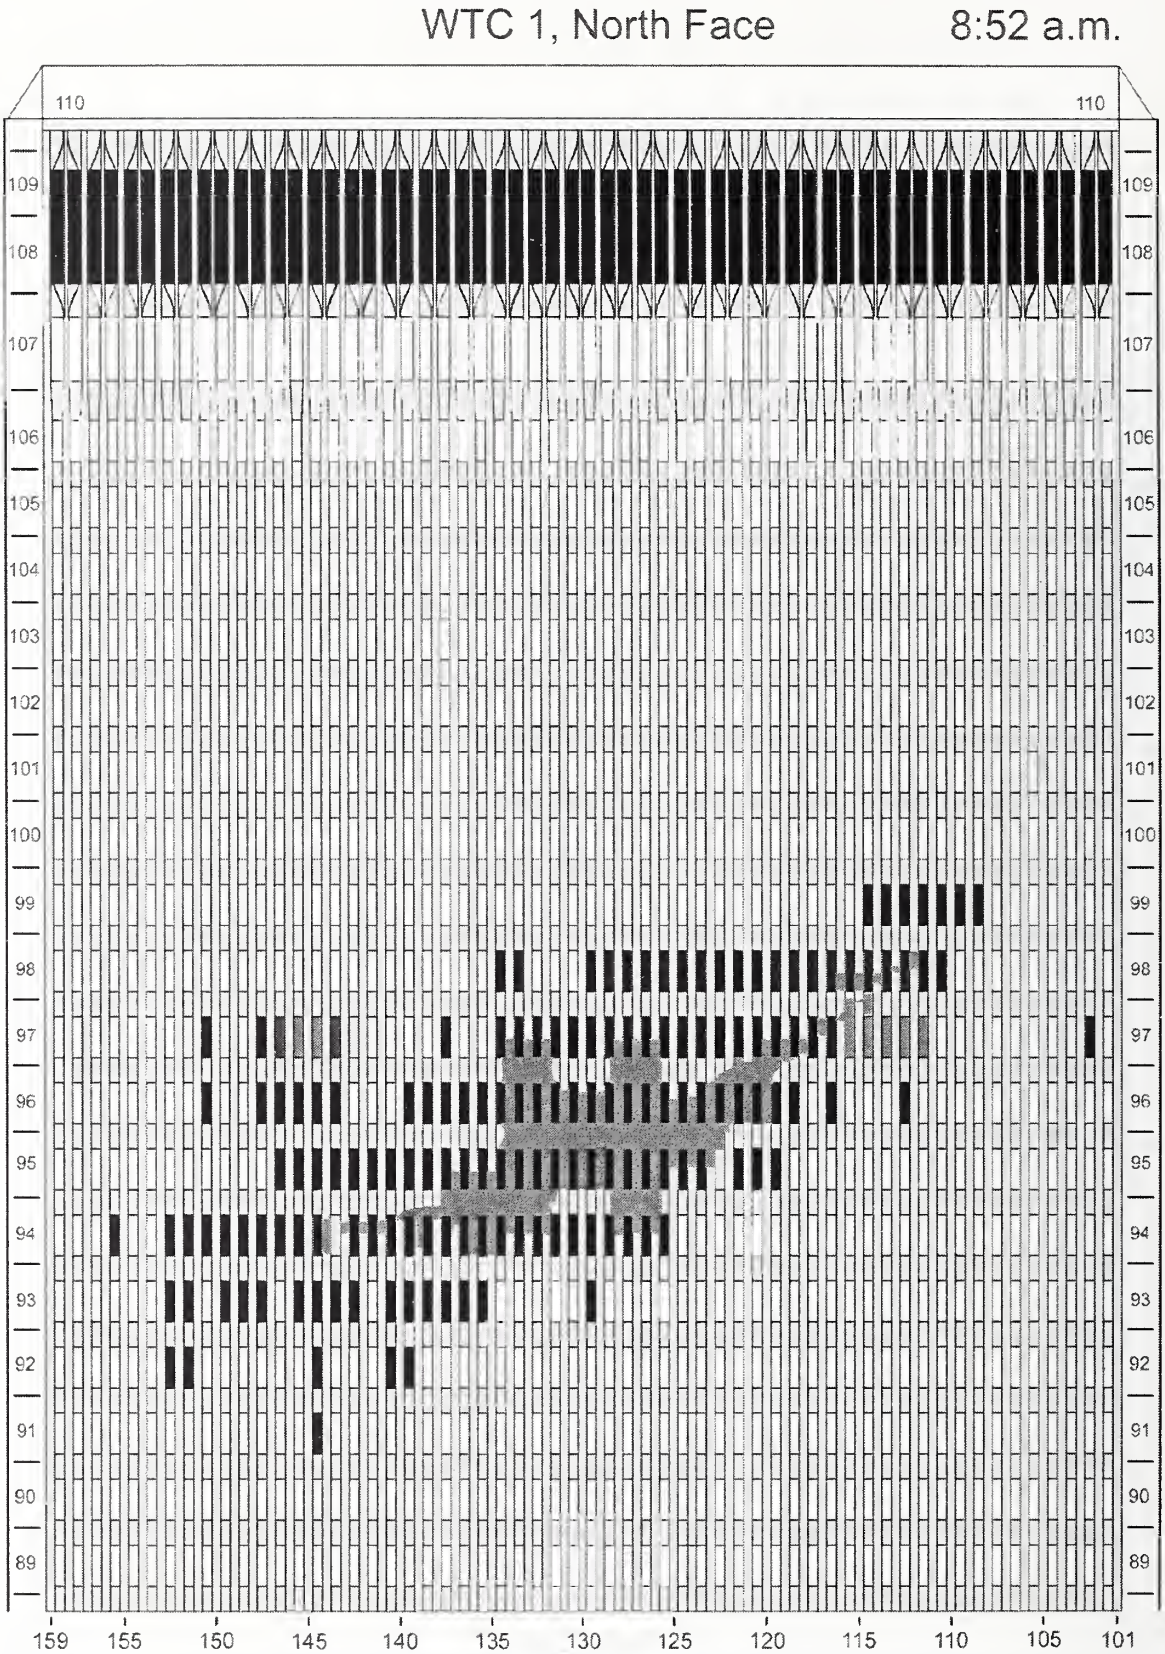
Figure C-7. Diagram of the north face of WTC 1 for floors 89 to 110 at 8:52 a.m. showing the condition of windows and locations of fires.

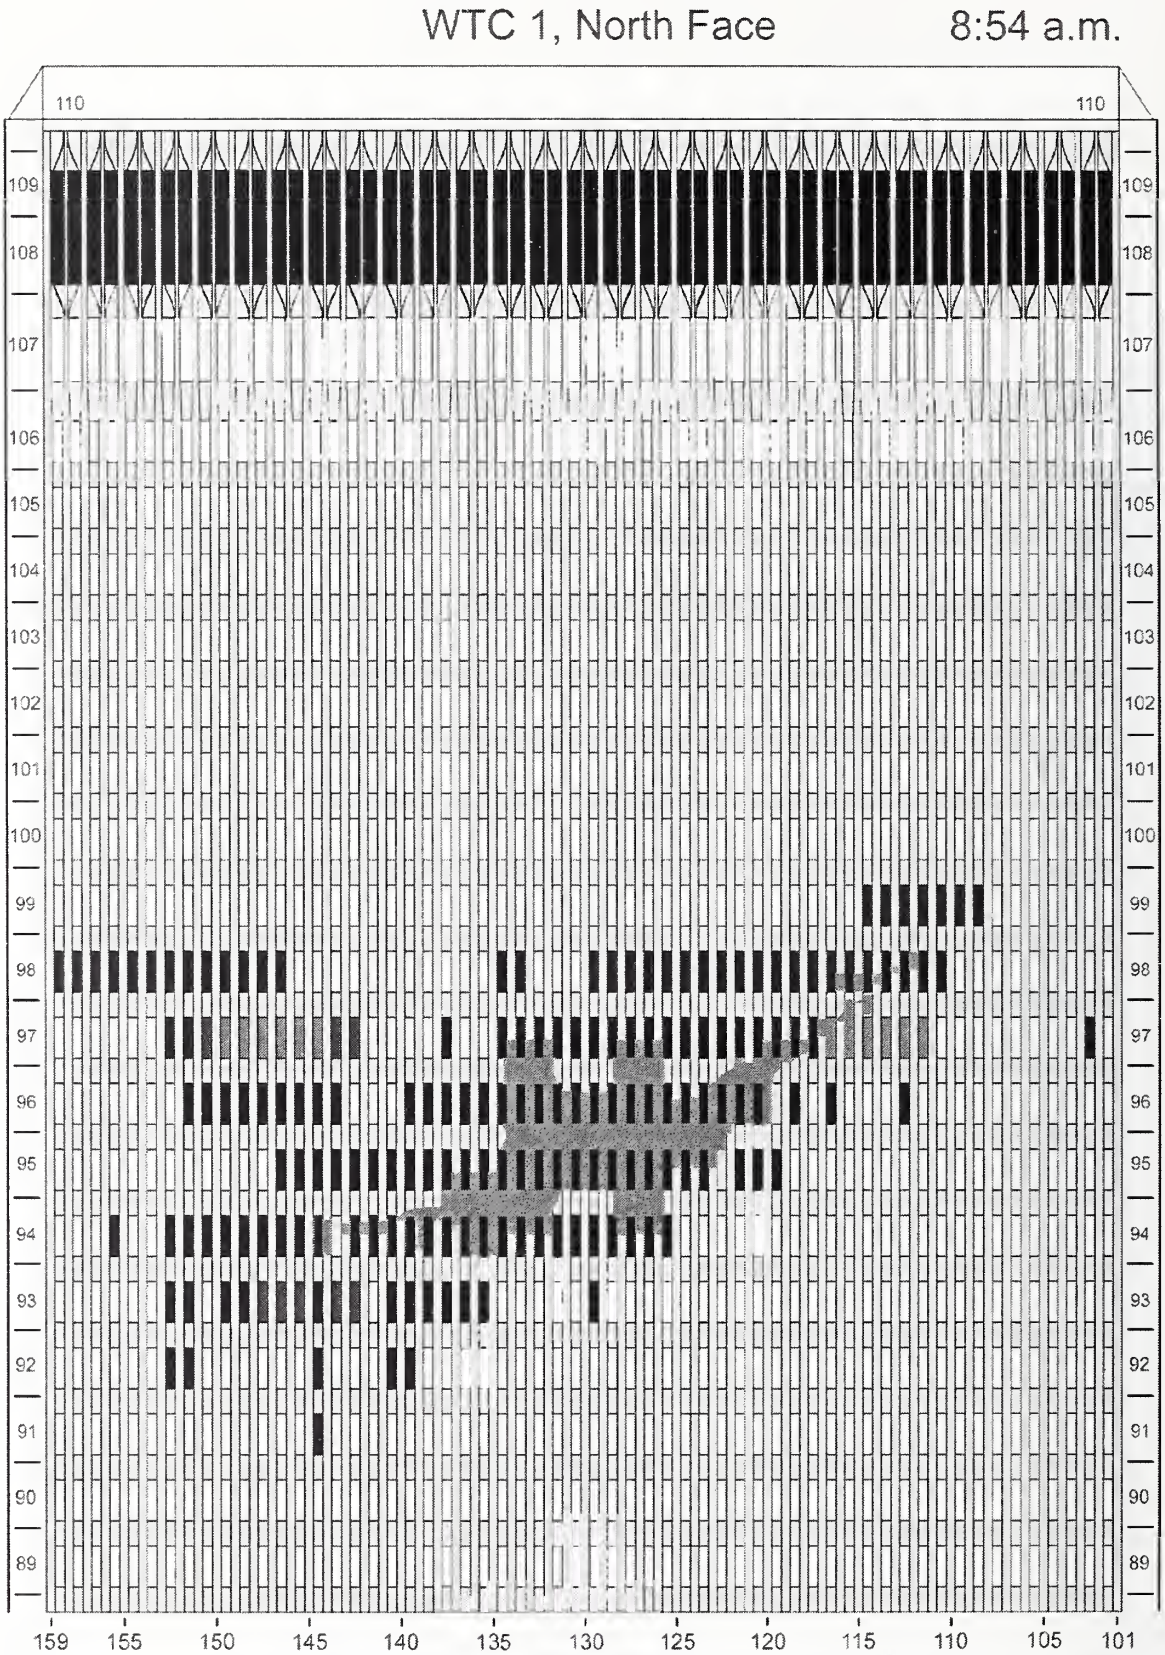
Figure C-9. Diagram of the north face of WTC 1 for floors 89 to 110 at 8:54 a.m. showing the condition of windows and locations of fires.

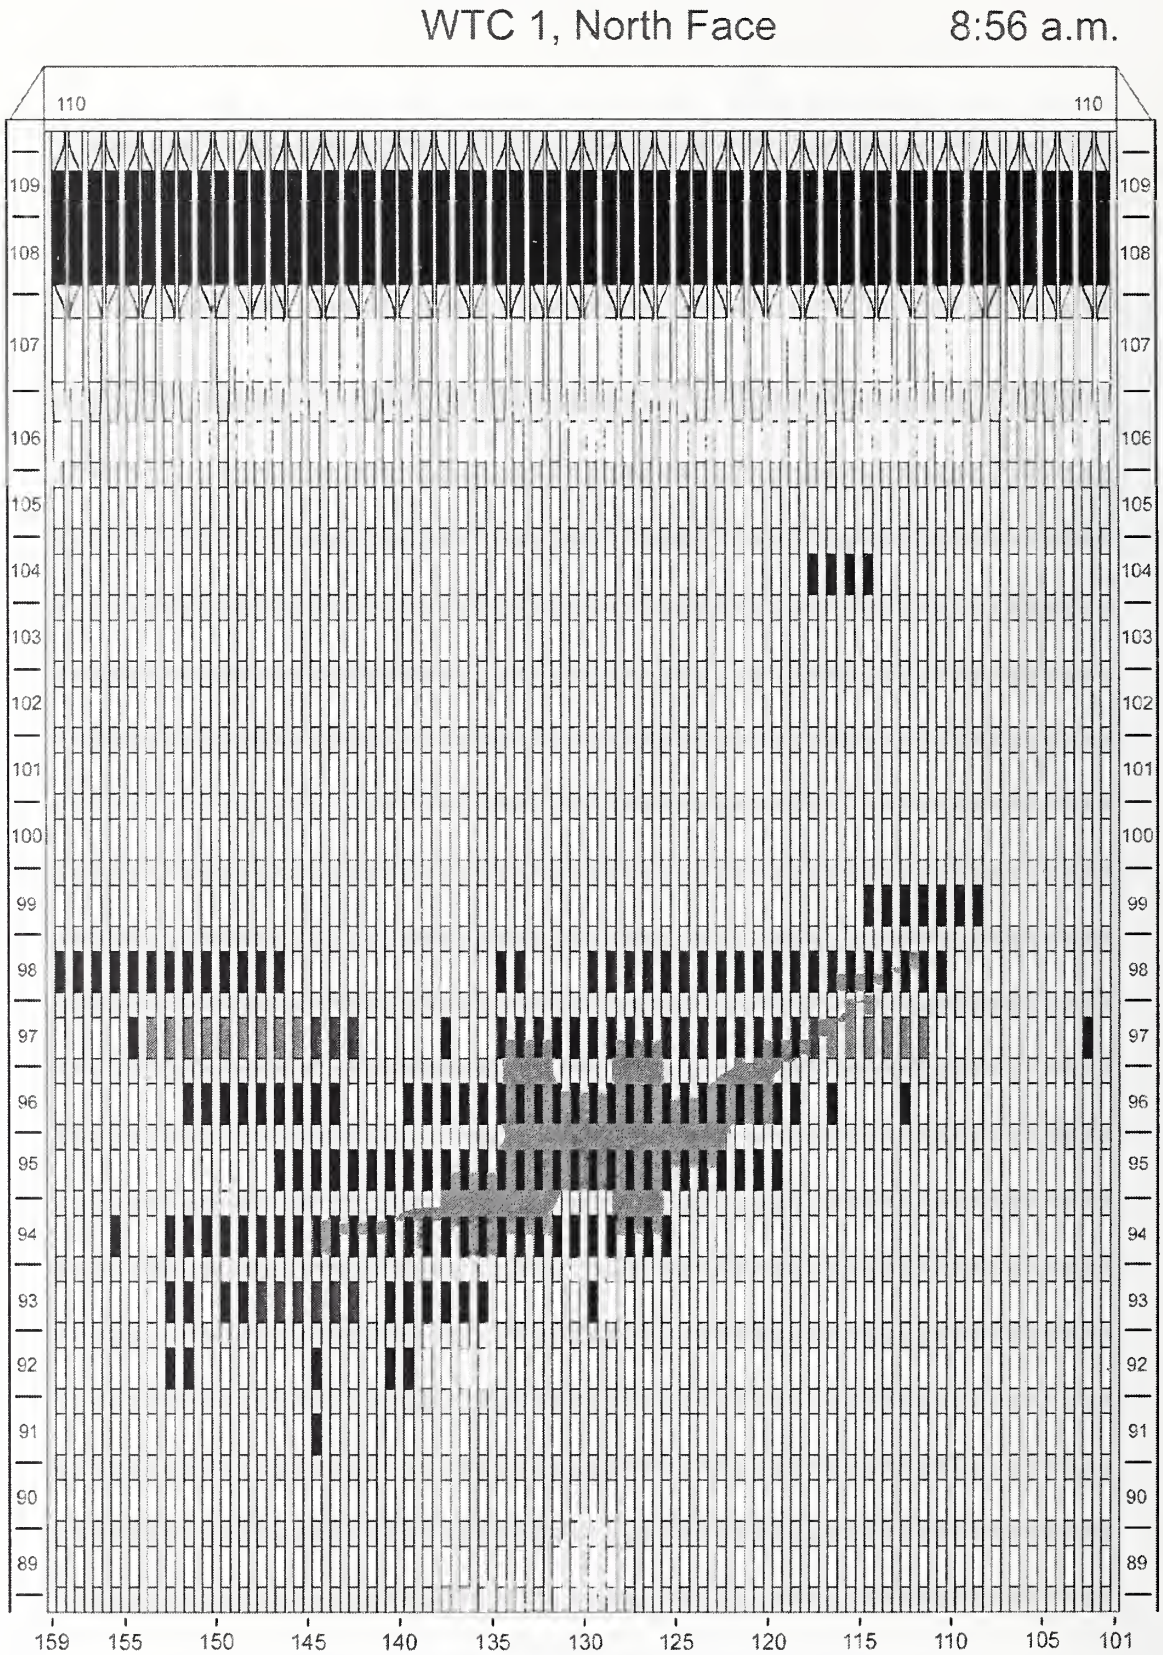
Figure C-11. Diagram of the north face of WTC 1 for floors 89 to 110 at 8:56 a.m. showing the condition of windows and locations of lines.
